PULL-OUT MECHANISM DETAILED MICROMECHANICAL INVESTIGATION IN SITUATION WHEN OUT OF CONCRETE IS PULLING STRAIGHT STEEL FIBRE

Abstract. Concrete matrix samples with steel fibres embedded into concrete under different angles were fabricated and tested for pull-out test, pull-out force versus pull-out fibre length diagrams were obtained. Microscopic investigations of the samples after rupture were carried out and fibre canal geometrical parameters were measured. On the basis of microscopic investigations and pull-out diagrams mechanical behaviour of straight steel fibre with different inclination angles was thoroughly analysed. Average energy of the pull-out test for each fibre inclination angle was obtained.

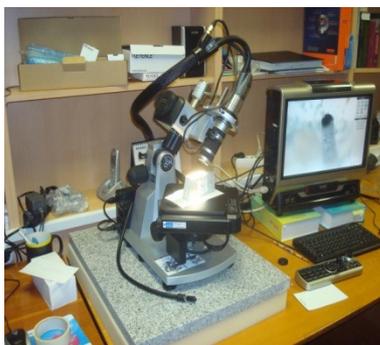
Fig. 1. Surface scanning at 40 °

The fabricated samples contained straight steel fibre symmetrically embedded by ends into two pieces of concrete. Fibre was 26 mm long with the diameter in a range $0.45 \div 0.5$ mm. One sample is shown in Fig. 1, 2. The samples were tested for fibre pull-out [1] and the pulled out parts were studied using a scanning measuring microscope KEYENCE VHX 2000 [2] with a digital computed video camera and image processing software, shown in Fig. 1. This microscope allows to receive 2D and quasi 3D images.

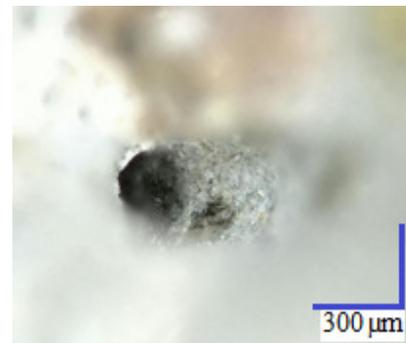
Fig.18. Channel surface left by the oriented fibre at an angle of 10° in sample N55
