USING OF ELECTRON MICROSCOPY FOR TOOL WEAR EVALUATION

Abstract. Using of cutting inserts is currently a normal part of the manufacturing process. The article deals with the tool wear evaluation of selected inserts for turning by electron microscopy. Use of electron microscopy helps closer analysis of machining consequences for these plates, because the microscope images captured with the electron microscope have a greater depth of sharpness and can display the examined object with greater plasticity. It is another way to explore objects and extends the possibilities for obtaining large quantities of information. Electron microscopy is possible to be used for getting better information about toolwear after machining, for example, too. One of the possible usages during the research is in the area of tool life of cutting inserts, which is realized at the Faculty of Production Technology and Management of Jan Evangelista Purkyně University in Ústí nad Labem. As part of this research various analyzes were also carried out. Part of such research was to analyze the resulting tool wear of the used inserts after turning of selected material also by electron microscopy, specifically the SEM

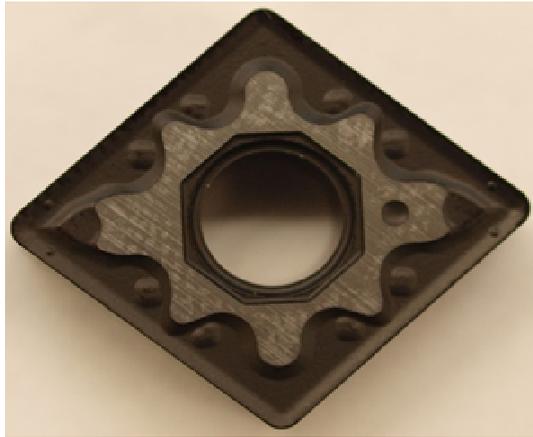
Fig. 1. CNMG 120408-M KT-CTP25

For the analysis cutting inserts (plate) were delivered CNMG 120408-M KT-CTP25 (Fig. 1.), CNMG 120408E-M GRADE T9325 (Fig. 2.), and CNMG 432-PM 4325 (Fig. 3.). According to the description these were inserts of cemented carbide and coated.

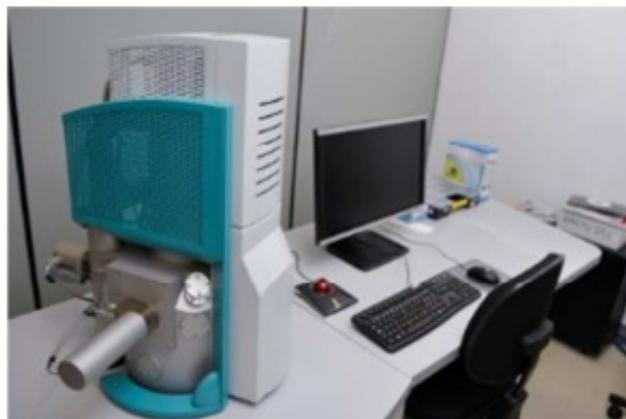
Fig. 4. Scanning electron microscope Tescan Vega 3

At all replaceable cutting inserts the SEM analysis has been carried out. For evaluation of the inserts the scanning electron microscope Tescan Vega 3 was used (Fig. 4.), which is at FPTM JEPU available [9; 10].

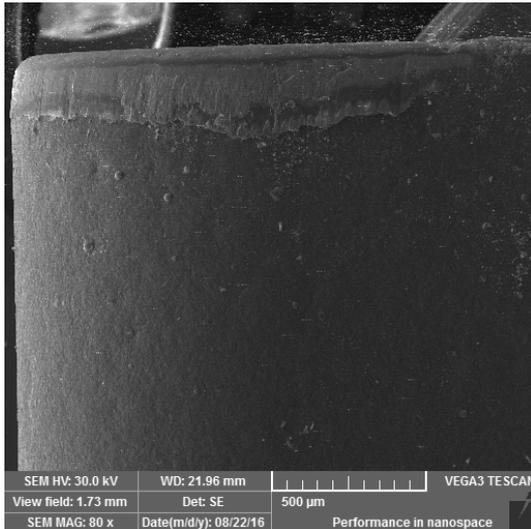
Fig. 5. CNMG 120408-M KT-CTP25,
 $v_c = 80 \text{ m}\cdot\text{s}^{-1}$

Fig. 5 shows the cutting insert CNMG 120408-M KT-CTP25 after machining by $v_c = 80 \text{ m}\cdot\text{s}^{-1}$. It was possible on the SEM image to observe the typical course wear for the cutting tool. This wear was less intense compared to higher speeds.

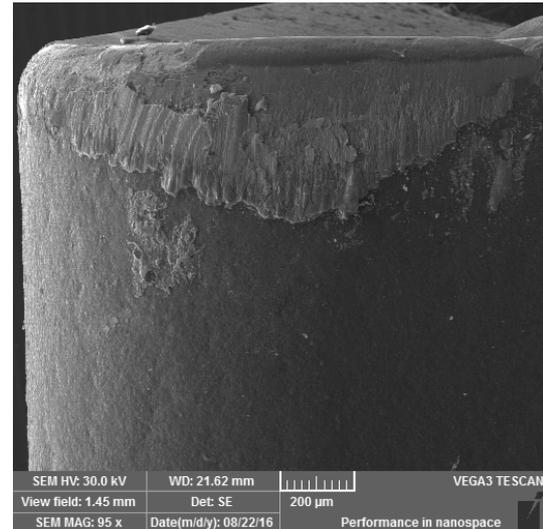
Fig. 6. CNMG 120408-M KT-CTP25,
 $v_c = 100 \text{ m}\cdot\text{s}^{-1}$

For the cutting insert after machining by $v_c = 100 \text{ m}\cdot\text{s}^{-1}$ (Fig. 6.) it was possible to observe wear where already violation of the tool coating was apparent.

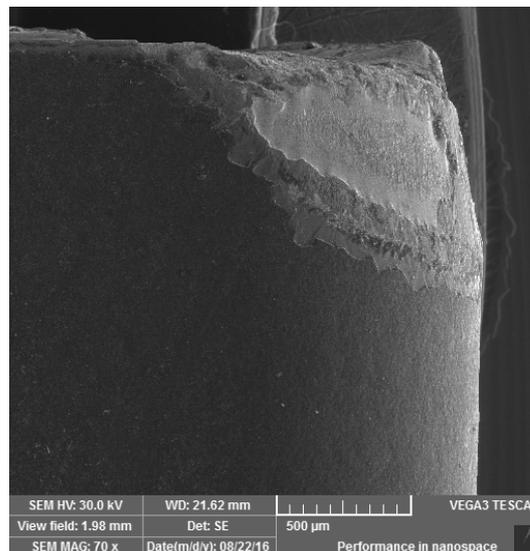
Fig. 7. CNMG 120408-M KT-CTP25, $v_c = 120 \text{ m}\cdot\text{s}^{-1}$

For the cutting insert after machining by $v_c = 120 \text{ m}\cdot\text{s}^{-1}$ (Fig. 7.) it was possible to observe relatively extensive and intensive wear of the tip and the flank wear. In this figure there are clearly visible individual layers of the coating and the substrate of the cutting insert. It could be a delamination wear, which is for coated inserts relatively common. This insert showed the worst results from all three of the investigated inserts.

For the experimental insert CNMG 120408-M KT-CTP25 it was possible to state that according to the SEM analysis the tool wear in the place of the tip has been fairly intense, there are also delaminated layers of the insert coating up to its substrate.

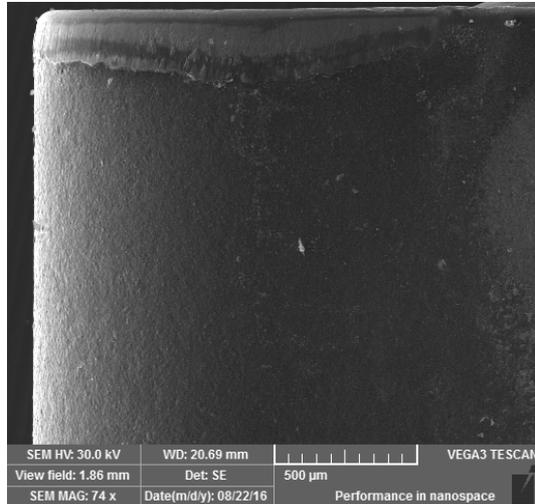
Fig. 8. CNMG 120408E-M GRADE T9325, $v_c = 80 \text{ m}\cdot\text{s}^{-1}$

Fig. 8 shows the cutting insert CNMG 120408E-M GRADE T9325 after machining by $v_c = 80 \text{ m}\cdot\text{s}^{-1}$. It was possible on the SEM image to observe the typical course wear for the cutting tool, similar to the insert CNMG 120408-M KT-CTP25 ($v_c = 80 \text{ m}\cdot\text{s}^{-1}$).

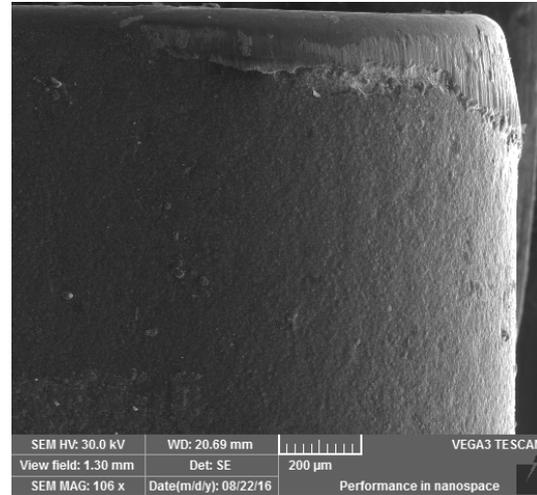
Fig. 9. CNMG 120408E-M GRADE T9325, $v_c = 100 \text{ m}\cdot\text{s}^{-1}$

Figure 9 shows the cutting insert for $v_c = 100 \text{ m}\cdot\text{s}^{-1}$ according with the SEM analyses. From this picture it is possible to see similar consequences like for $v_c = 80 \text{ m}\cdot\text{s}^{-1}$, see Fig. 8, the wear on the tip of the tool is greater in comparison with the wear for $v_c = 80 \text{ m}\cdot\text{s}^{-1}$.

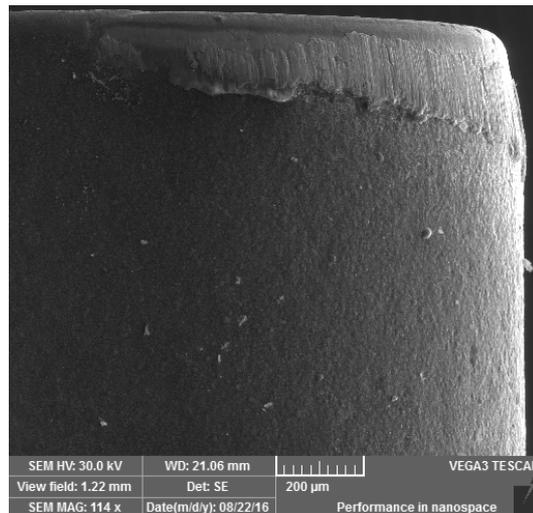
Fig. 10. CNMG 120408E-M GRADE T9325, $v_c = 120 \text{ m}\cdot\text{s}^{-1}$

The SEM analysis of this insert for $v_c = 120 \text{ m}\cdot\text{s}^{-1}$ (Fig. 10.) showed that the tool wear of the insert took place uniformly without obvious signs of other damage. The cutting edge is in good condition, there is not visible delamination of coatings in comparison with CNMG 120408-M KT-CTP25.

For the experimental insert CNMG 120408E-M GRADE T9325 it was true that the wear according to the SEM analysis was uniform, there was not delamination of the coating layers, neither tearing off of the particles.

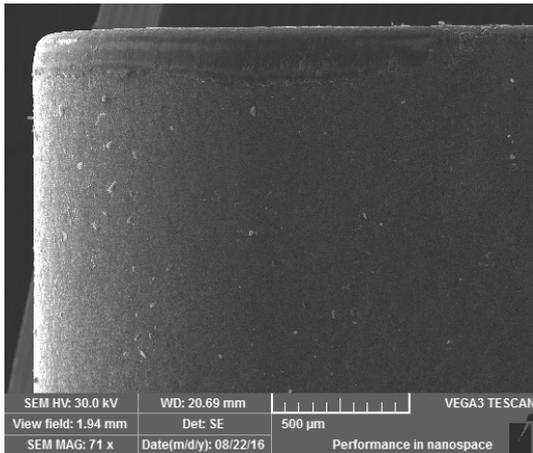
Fig. 11. CNMG 432-PM 4325, $v_c = 80 \text{ m}\cdot\text{s}^{-1}$

For the insert CNMG 432-PM 4325 ($v_c = 80 \text{ m}\cdot\text{s}^{-1}$) in Fig. 11, there can be observed uniform abrasive wear on the flank and tool tip with the classic course. On the area of the flank is again wear visible similar to what the previous inserts had. This wear by the SEM analysis, compared with the previous, does not reach such a depth and is received only in the second coating, there is no visible penetration in the substrate.

For the experimental insert CNMG 432-PM 4325 there could be observed a uniform abrasive wear on the tool flank and tool tip with the classical course. On the area of the flank again wear similar to what the previous inserts had is visible.

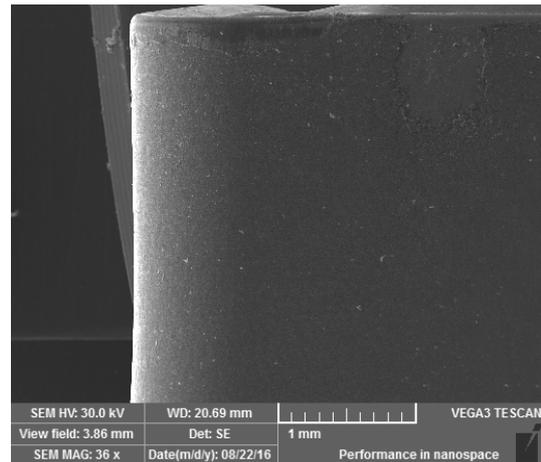
Fig. 12. CNMG 432-PM 4325, $v_c = 100 \text{ m}\cdot\text{s}^{-1}$

Fig. 12 shows tool wear for $v_c = 100 \text{ m}\cdot\text{s}^{-1}$. Fig. 13 shows tool wear for $v_c = 120 \text{ m}\cdot\text{s}^{-1}$. The cutting edge is in good condition, there is not visible delamination of the coatings, like for CNMG 120408E-M Grade T9325.
