STUDY OF EXOTHERMIC WELDED JOINT GRINDING BY “SPENO” RAIL GRINDERS

Abstract. Exothermic welding joint is one of most common welded joints used in Europe. Latvian railway also uses exothermic welding for its rails in crossing pieces, station and railroad haul sections. Rail grinders are used to extend lifespan and maintain the tread surface of the rail's head and to remove and eliminate defects in the surface layer and to reduce corrugated rail wear. Rail grinders supplied by the company “Speno” are used in Latvian railways. This article will discuss the quality of grinding of exothermic welding joint of rail profile 60 E1 by “Speno” rail grinder. The research also includes analysis of ground rails in the Latvian railway during 2014, 2015, 2016, 2017 and 2018. First, detailed hardness of metal has been determined: on the tread surface, head, web and base, according to the Brinell scale by using the modern equipment “Tinius O Olsen” Fikrware Version 1.07, FH-31 Series. Second, the chemical composition of an exothermic welding joint of rail steel (in head, web, base) has been examined with the optical emission spectrometer “ARC-MET 8000 Mobile Lab”. The obtained data have been compar

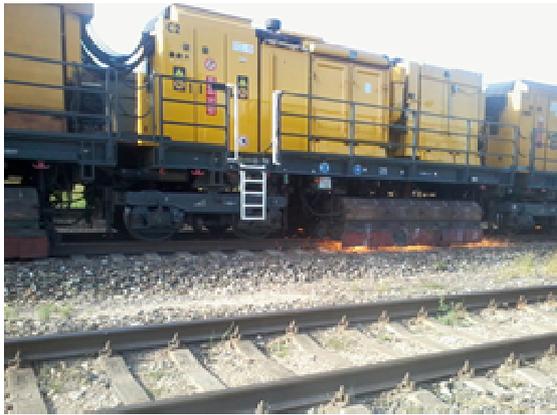
Fig. 1. Grinding of 1st main track in station Taurkalne with “Speno” rail grinder

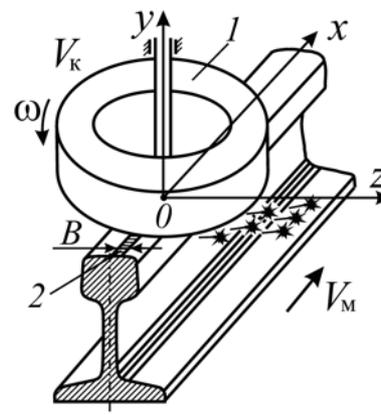
Fig. 2. Rail grinding pattern: 1 – abrasive wheel; 2 – area of metal grinding

Profile grinding of the rail head of the track is done due to abrasive processing with rotating wheels (Fig. 2) by the “track” method of the lace of the cup wheel. The abrasive wheel 1 rotates around the OY axis and removes a strip of metal 2 from the rail at the width of B, giving the transverse motion of the mechanism along the rail [3]. For a comparison, in railways of the USA, having a huge working capacity, the rails are ground to remove fatigue cracks and to have rail heads profiled. Besides, the frequency of grinding works is determined by 20 to 40 million tonnes gross in curved tracks with small and average radiuses and 40 to 80 million tonnes gross in curved tracks with a large radius and on the straight sections of the track. On English and French railways grinding of rails is divided into: grinding of new rails after they are laid in to remove the factory defects; planned and preventive grinding allowing to remove defects that consequently lead to micro cracks; grinding to repair and restore through profiling of the rail head. Besides rail grinding works are done at the speed of $1-2 \text{ km}\cdot\text{h}^{-1}$ in case of the cutting depth of $0.1-0.4 \text{ mm}\cdot\text{step}^{-1}$ [4]. Federal railways in Germany are mainly ground to remove short-pit corrugations on the high-speed sections of the track.

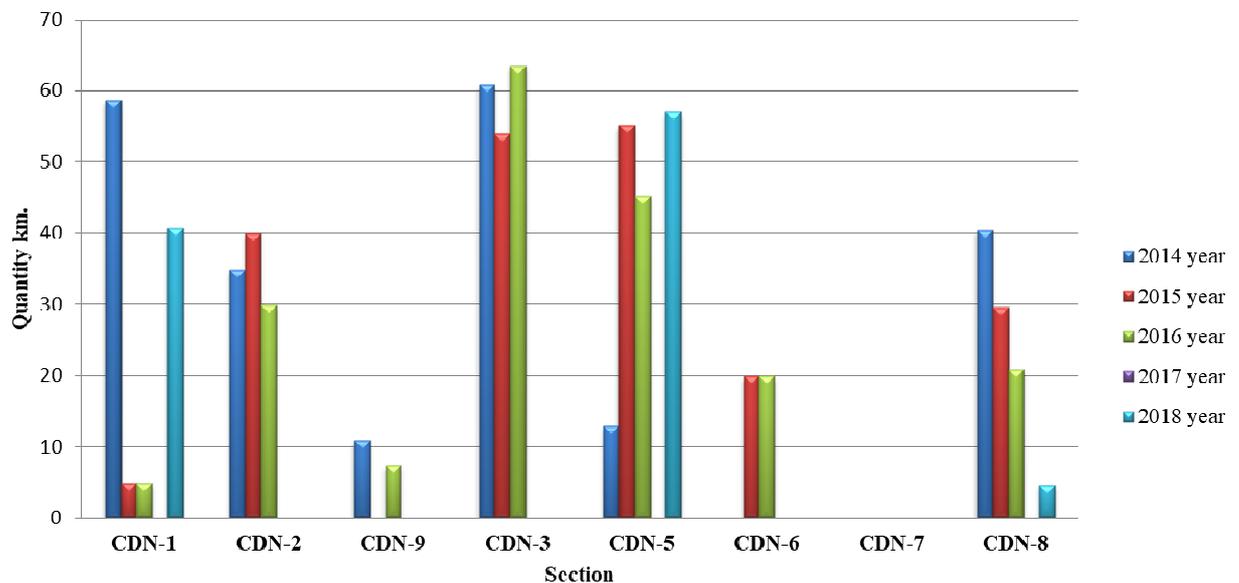
It follows from the diagram in Fig. 3 that in 2014 the majority of rail grinding took place in **CDN-3** Daugavpils branch 60.82 km. tracks, in **CDN-1** Skirotava branch it totalled in 58.676 km of track, in **CDN-8** Jelgava branch 40.40 km of track were ground, while in **CDN-2** Ciekurkalns track 34.90 km of track were ground. In **CDN-5** Rezekne branch 12.852 km of track and in **CDN-9** Riga branch 10.850 km of track were ground.

Fig. 3. Statistical diagram of rails ground by Speno rail grinder between 2014 and 2018 Latvian railway is divided into eight individual sections, out of them: CDN-1 Skirotava branch; CDN-2 Ciekurkalns branch; CDN-3 Daugavpils branch; CDN-9 Riga branch; CDN-5 Rezekne branch; CDN-6 Ventspils branch; CDN-7 Liepaja branch; CDN-8 Jelgava branch

To fully evaluate efficiency of operation of the Speno rail grinder on the Latvian railways and individual sections, let us set up a statistical diagram (Fig. 3) of rails ground by the Speno rail grinder between 2014 and 2018.

The statistical diagram (Fig. 3) shows that in 2017 the rails of the Latvian railway were not ground.

In 2018 one can see a decrease in operation of the rail grinder in the railway branches, Fig. 3. Through an analysis one can arrive at a conclusion that in **CDN-2** Ciekurkalns, **CDN-9** Riga, **CDN-3** Daugavpils, **CDN-6** Ventspils and **CDN-7** Liepaja branches the rails were not ground. In **CDN-5** Rezekne branch the rails were ground in 57.00 km of track, in **CDN-1** Skirotava branch — 40.65 km of track and the least length of the rail track was ground in **CDN-8** Jelgava branch, totalling in 4.60 km of track.

1. Analysis of the diagram in Fig. 3 of the Latvian railway between 2014 and 2018 allows us concluding the following: total length of ground rails was 713.759km of track, and average statistical grinding of rails per year during the given period was 142.752 km of track. And it is only one twenty-first of the entire length of the Latvian railway spreading as far as 3.017 km. Accordingly, it proves one more time that it is more resource-effective for the Latvian railway to order grinding rather than have a rail grinder of its own.

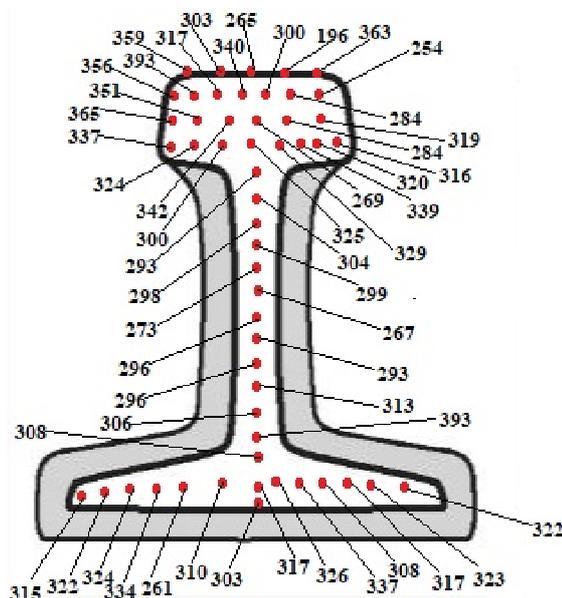
During the first stage of the study in a lab of the Riga Technical University (Laboratorijas mājas) the exothermic welding joint of rail steel was thoroughly tested for hardness by the Brinell scale (HB) with a device "Tinius O Olsen" Fikrmware Version 1.07, FH - 31 Series. Procedure to determine the rail steel hardness was performed in line with the standards (ISO 6508, ISO 2039/1, ASTM E18, ASTM B254, JIS Z2245). The study results are shown in Fig. 4.

Fig. 4. **Determination of hardness of ground exothermic welded joint in rail profile 60 E1 T IV 06 in HB:** on the tread surface of the exothermic welded joint (359, 303, 265, 196, 363); in the head of the exothermic welded joint (356, 393, 317, 340, 300, 284, 254, 365, 351, 342, 269, 284, 319, 337, 324, 300, 325, 329, 339, 320, 316); in the web of the exothermic welded joint (293, 304, 298, 299, 273, 267, 296, 293, 296, 313, 306, 393, 308); in the base of the exothermic welded joint (315, 322, 324, 334, 261, 310, 326, 337, 308, 317, 323, 322, 317, 303)

It was found from the performed studies that the hardness of the tread surface of alumino-thermic welding of rail joints in a number of cases does not meet the required indicators of applicable technical standards. According to instructions for alumino-thermic welding of rails C-015, hardness of alumino-thermic welded joints on the tread surface must be close to the hardness of quenched rails and reach the values 342-385 HB, while in the samples under examination hardness was 297 HB, being essentially below (45 HB) the permissible values. Hardness of the head of the exothermic welding joint is 322 HB, which is by 47 HB below the permissible value specified in the applicable instruction C-015 [8]. Hardness of the welded seam is 303 HB, which is by 85 HB below the standard. Nature of change in hardness of rail web in area of thermal impact is the same as in the welded joints of the rail

head, while the structure of the welded joints of the rail web is coarser than in the rail head. Hardness in the area of the welded joints of the rail base is 316 HB, which is essentially below (72 HB) the values of hardness of the welded joints in the head and web of the rail. Decreased hardness on the tread surface of the welded joints leads to uneven wear during their operation and is an underlying cause for crumbling of the rail head. The obtained results of hardness evaluation therefore indicate a necessity to apply technical solutions such as grinding of rails by rail grinders that would remove the noticed shortcomings.

2. The following conclusions can be drawn from the hardness tests performed on the exothermic welding joint: decreased hardness in the tread surface is 297 HB, which is by 45 HB lower than the permissible values. Lowered hardness in the rail head can lead to uneven wear during the operation and can be a cause of crumbling of the rail head. Hardness in the head of the exothermic welding joint is 322 HB, which is by 47 HB less than the permissible value under the applicable instruction C-105. Hardness in the rail web is 303 HB, which is by 85 HB less than the claimed one. In the area of welded seams the rail base hardness is 316 HB, which is by 72 HB less than the claimed hardness of the base.

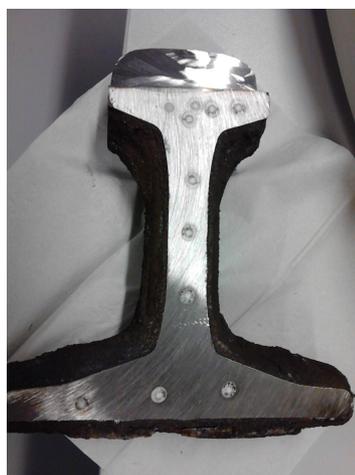
In the second part of the study in the Metallographic Laboratory of the Riga Technical University the chemical composition of metal in three points of the allumino-thermic welded joint (head, web, base) was analysed. The exothermic welding joint was cut out from two welded rails with a rail-cutting circular saw. Afterwards, the sample was polished with a sander, reaching a mirror-like surface, Fig. 5 [9]. The chemical composition of the metal was determined with the optical emission spectrometer PMI-Master PRO, operating according to the principle of local burning of the sample's surface followed by determination of the chemical composition and transfer of the obtained data to a printing device. Measuring was done three times in three different points: in the head, web and base of a counter-rail [10]. The average results of the analysis of the chemical composition of the samples are shown in Table 2.

Fig. 5. Determination of chemical composition of ground exothermic welding joint: head, web, base

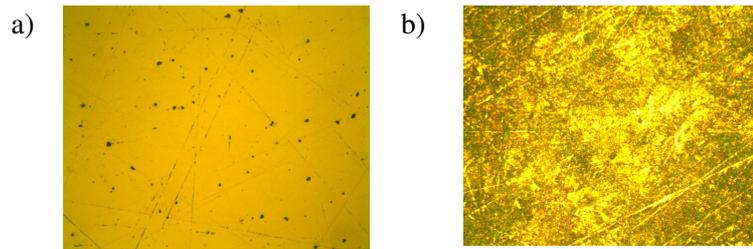
The images obtained in the examination are shown in Fig. 6 a), b). One can draw the main conclusions from the results obtained concerning the quality of the exothermic welding joint. Inclusions appearing as black spots are found in the metal structure. One can assume that these are residuals of black grains (iron scale) that have not melted completely in a reaction of thermite joint formation. Phosphorous and sulphur content in the given chemical composition complies with the established range.

Microstructural analysis showed that the structure of the welded seam of the rail head, shown in Fig. 6 b), makes a coarse-grained structure, meaning that this area adjacent to the welding area was overheated and the large grains of austenite resulted in formation of lamellar pearlite with a ferrite network. Large-grained structure usually has lower plasticity and impact resistance. Lower impact resistance has an adverse impact on durability of metal leading to brittle fracture.

Fig. 6. Metal structure in polished exothermic welding joint under microscope at X200 magnification (a); metal structure in polished exothermic welding joint under microscope after corrosion with nitric acid (HN03) at X500 magnification (b)

For the first time on the Latvian Railway in the Laboratories of the Riga Technical University the given results of tests in the area of exothermic welding joints were obtained, and grinding with the “Speno” rail grinder allows evaluating the condition and efficiency of the method of “trail” grinding with the lace of a cup wheel pattern and also shows the use of this method in countries such as the USA, England, France, and Germany. Hardness of the exothermic welding joint was determined in line with the applicable instruction **C-015**. Data of hardness in the thermite joint in the head, web and base have poor values and discrepancies with the technical standards specified in the instruction **C-015**, thus indicating at poor quality of the exothermic welding joint. Results of the study are true, since they were double-checked with a modern hardness tester “**Tinius O Olsen**” **Fikrmware Version 1.07, FH-31 Series**, confirming the obtained results in line with the standards **ISO 6508** and **ISO 2039/1**. Chemical composition was determined with an optical emission spectrometer PMI-Master PRO, calibrated and tested on analogous samples of welded joints. The following was established during the tests: content of main chemical elements such as Al, S, P, Cr meets the standard EN 13674-1:2011, with reduced mass fractions of C and Mn. Structure of the exothermic welding joint is large-grained in the welded area, because the area adjacent to the welding area was overheated and the large grains of austenite led to

formation of lamellar pearlite with a ferrite network featuring inclusion of dark spots. Perhaps, these are residuals of black spots (iron scale). Residuals of such elements can facilitate development of a defect and fracture in an exothermic welding joint.

5. When examining the exothermic welding joint, inclusions were detected appearing as black spots. One can assume that presence of remains of black grains (iron scale) in an exothermic welding joint indicates at poor quality of metal. Examinations of the metal structure also support a reduced impact resistance that has an adverse impact on the resistance of metal to brittle fractures.
