RESTORATION OF THE WORKING BODY OF THE JOHN DEERE 512 DISK RIPPER WITH MULTI-LAYER FRONT SURFACING

Sergey Strebkov, Alexey Slobodyuk, Andrey Bondarev

Belgorod State Agricultural University named after V. Gorin, Russia
serwastr@gmail.com, aspl22@yandex.ru, av.bondarev@gmail.com

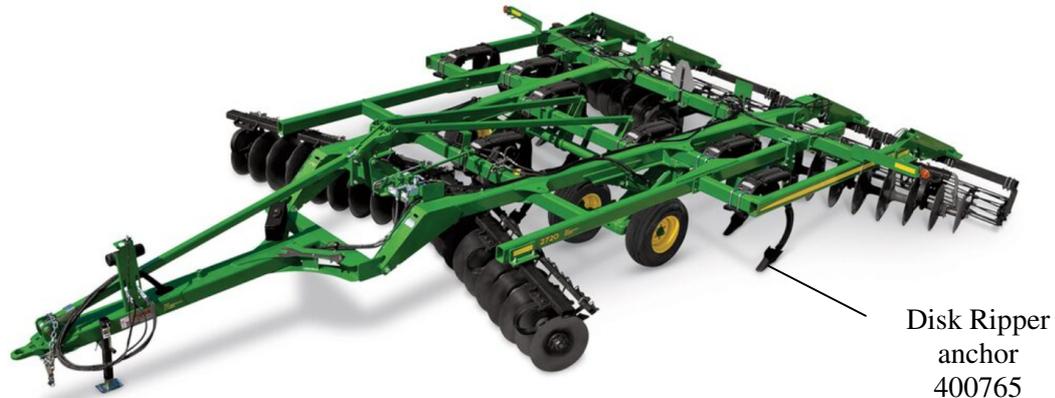
The 512 Disk Ripper (Fig. 1) is characterized by a two-element design of the working body, which includes a stand providing load-bearing capacity, and a removable tip designed for loosening the soil to a depth of 60 cm. The tip directly contacts the soil abrasive at high contact pressure and, in this regard, is a “weak” structural element with a resource significantly less than the life of the rack, the failure of which occurs due to fatigue or catastrophic failure.

Fig.1. John Deere 512 Disk Ripper with anchor arrangement

The Ripper 512 design provides increased reliability by providing a high level of maintainability. This is manifested in the replacement of a quick-wear element-the anchor (tip), and not the entire rack. It is supplied by the dealer as spare part with high added value. However, their resource is not increased, and manufacturers do not provide measures to improve wear resistance. The resource is provided by the structural material-high-strength cast iron, from which the tip is made by casting. A number of studies have been conducted to assess the possibility of carrying out renovation activities.

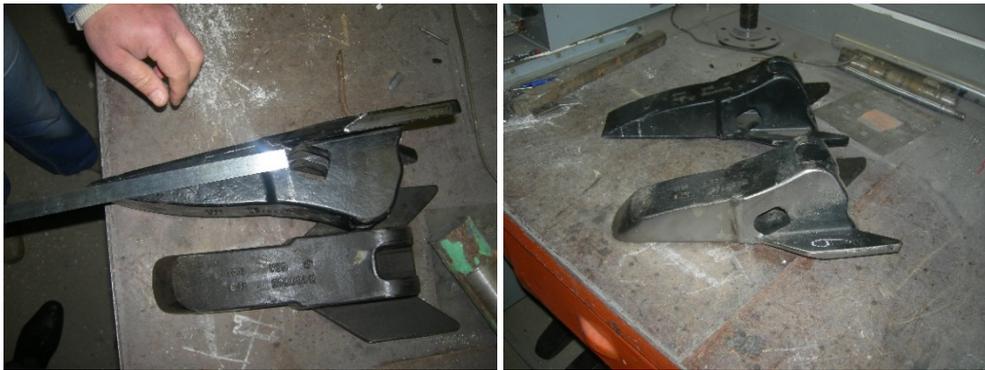
Analysis of the wear of the tip under operating conditions showed (Fig. 2) that the limit state occurs, when an average of 0,9 kg or 8.5 % of the tip weight is lost due to weight wear. The results of micrometering showed that the linear change in the “toe-heel” parameter reached the limit on average with a decrease in size by 34.2 mm or 9.7 %, and the “toe-front hole” parameter reached the limit on average with wear of 65.8 mm or 16 % of the values of the new anchor. Therefore, the obvious fact is the presence of 84-90 % of the unused residual resource of the anchor. The average square deviation was no more than 10 g for weight wear and 1-3 mm for linear wear.

Fig. 2. View of the new and worn-out anchor

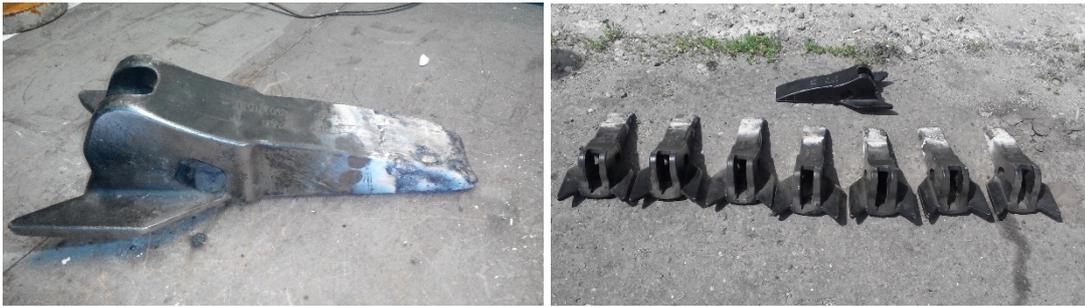
The restored anchors in all geometric parameters corresponded to the nominal sizes of the new one (Fig. 4).

Fig. 4. Anchor after the first restoration and complete set of anchors

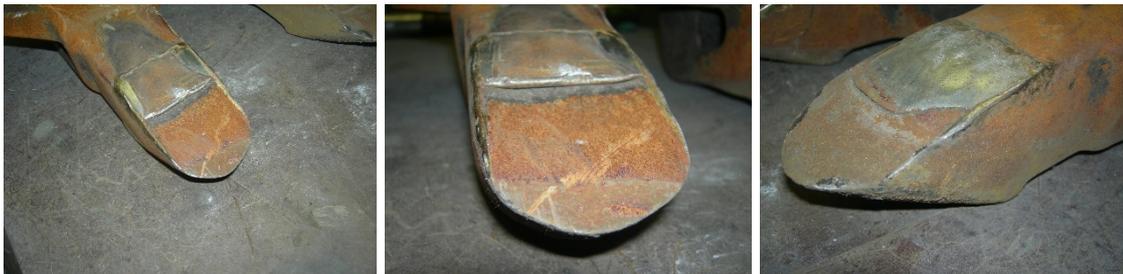
After restoration and hardening, the nature of the wear process changes (Fig. 5). The wear rate of the front part is reduced, while ensuring the implementation of the “self-sharpening” effect. This leads to a decrease in the resistivity of the working body.

Fig. 5. Change of the anchor wear

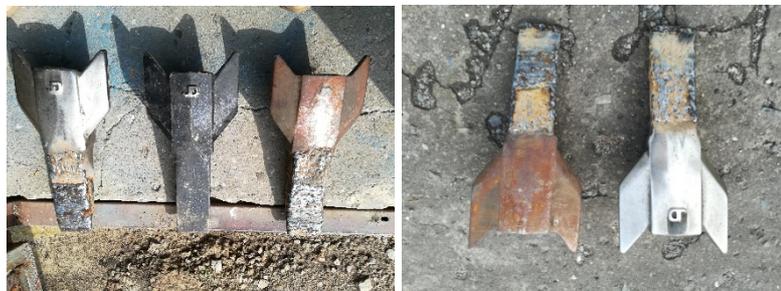
During the development of the technological process, the possibility of re-restoration of the anchor surface was checked. The difference between the technological process for the second and third surface restoration is the amount of the applied surfacing material. At the third restoration, it is 3-5 % more (Fig.6). It was found that the cutting surface of the anchor after the third restoration wears out 1.15 times slower than the anchor after the second restoration (Fig. 7). This is due to metallurgical processes during repeated surfacing.

Fig. 6. View of the anchor after the second and third restoration

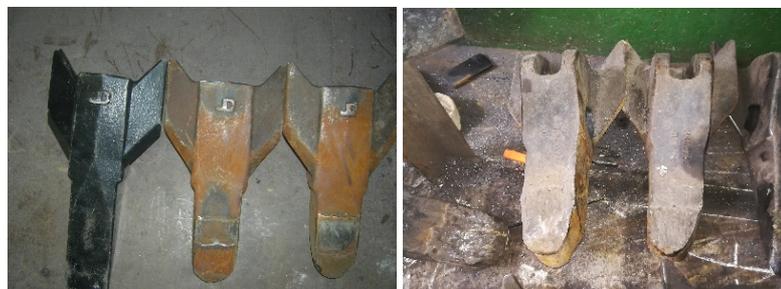
Fig. 7. View of worn anchors after the second and third restoration

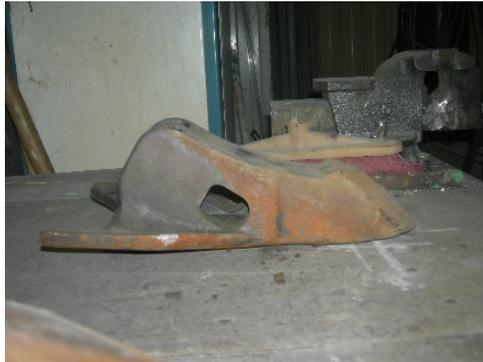
However, the feasibility of recovery is lost when weight wear is 28-32 % of the weight of the new anchor. This is due to the wear not of the front surface of cutting and crumbling, but to the loss of

mass of the side surfaces of the anchor and its “wings”. The remains of a previously restored and strengthened surface are seen in Fig. 8. In this case, the loosening process is completely disrupted.

Fig. 8. View of the extremely worn-out anchor that cannot be restored
